ASBESTOS AND LEAD BASED PAINT SURVEY REPORT Wiley's Well Safety Roadside Rest Area (srra) Riverside County, California

ROUTE: 08-Riv-10, PM 135.0

**Prepared for:
California Department of Transportation, District 8
Task Order No. 40
Contract No. 08A0981
EA OF3600**

October 24, 2007

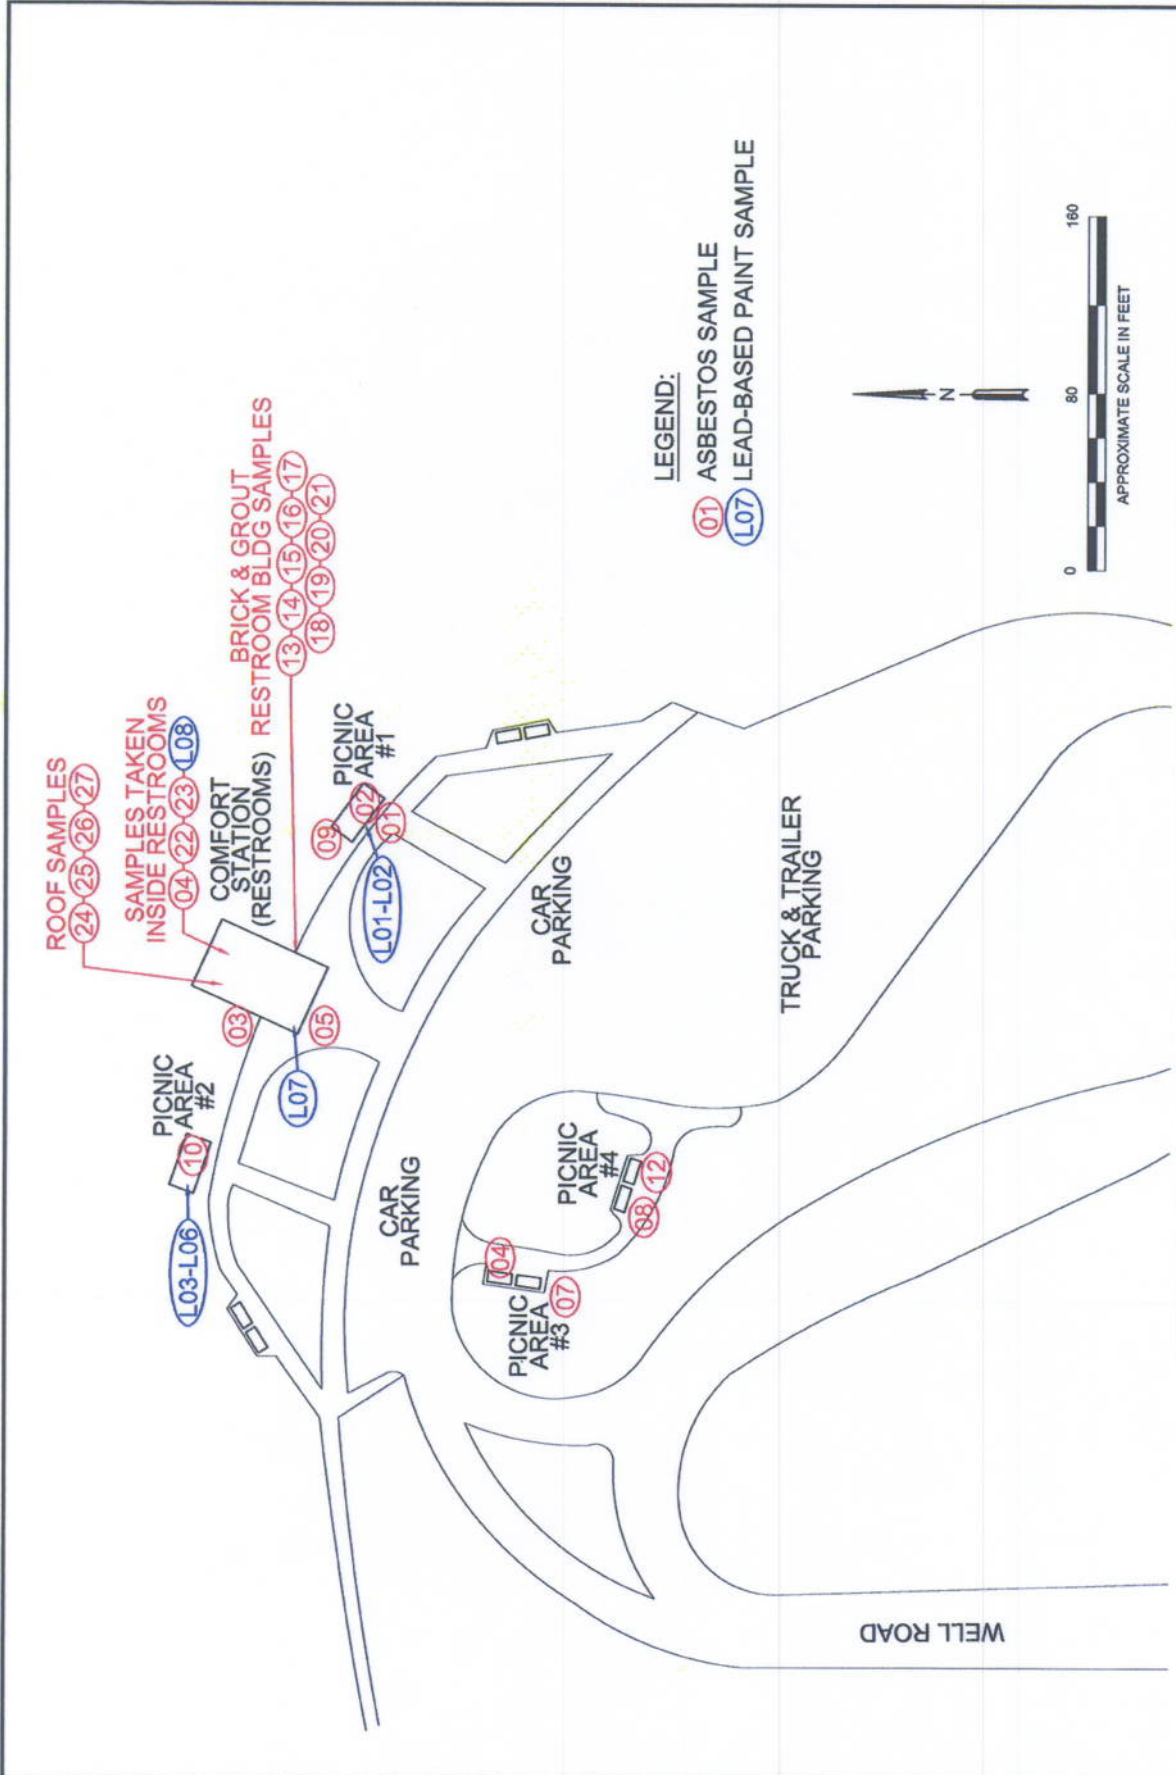
<p>FOR:</p> <p>CalTrans SAN BERNARDINO, CA</p>	<p>ASBESTOS & LEAD-BASED PAINT SAMPLE LOCATIONS</p> <p>WILEY'S WELL SAFETY ROADSIDE REST AREA BLYTHE, CALIFORNIA</p>	<p>FIGURE:</p> <p>2</p>
<p>JOB NUMBER: 040T.08098.01</p>	<p>CHECKED BY: TL</p> <p>APPROVED BY:</p>	<p>DATE: 10/12/07</p>

An inspection of the interior and exterior of the site improvements was conducted to evaluate the condition of painted surfaces and random surfaces suitable for lead-based paint sampling. Table 2 and Figure 2 identify the areas where lead-based paint samples were collected.

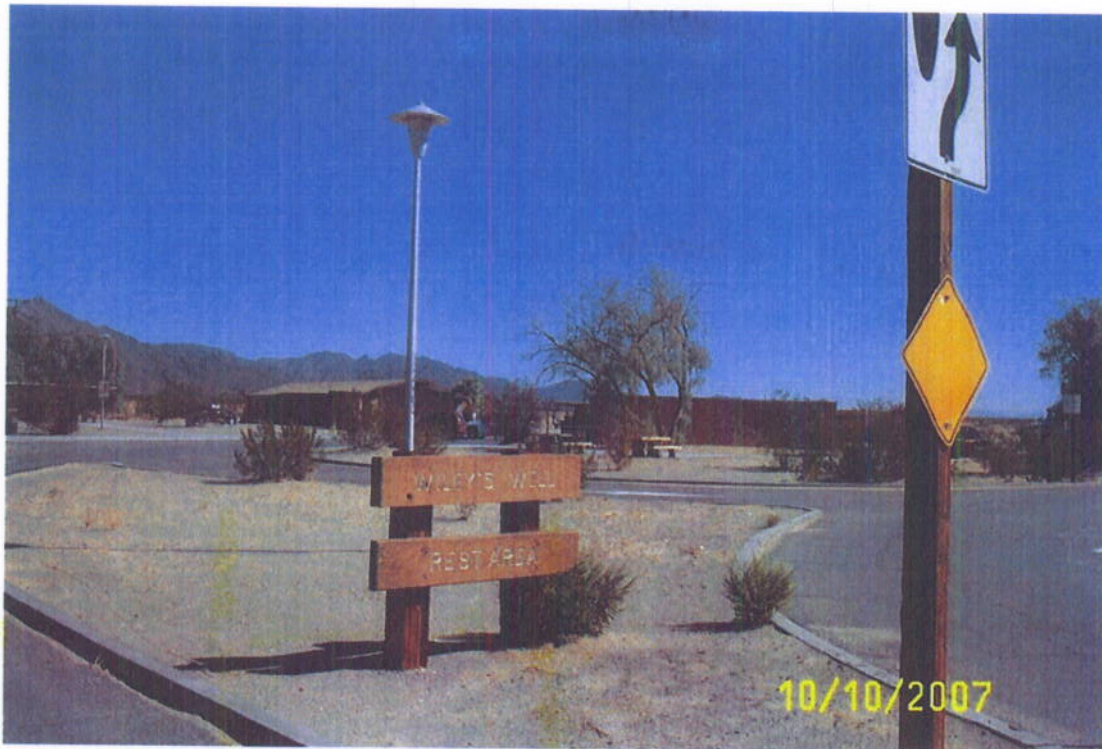
Photograph No. 1
View of Wiley's Well Safety Roadside Rest Area (SRRA)

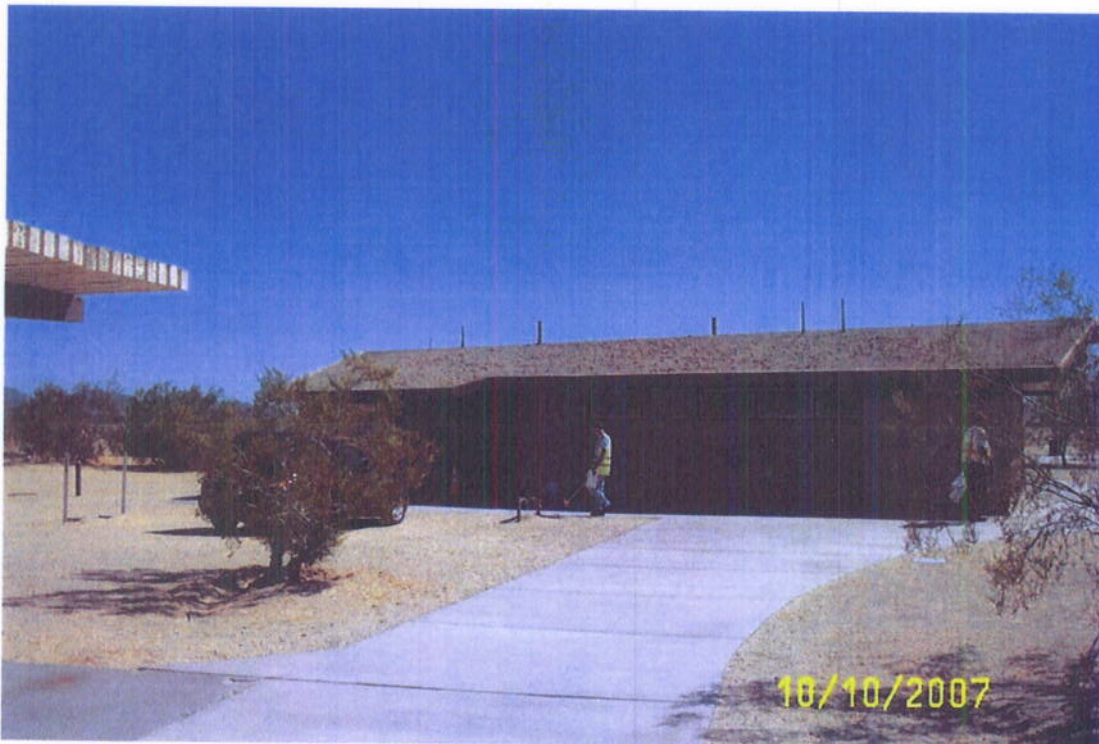
Photograph No. 2
View of Restroom Building.

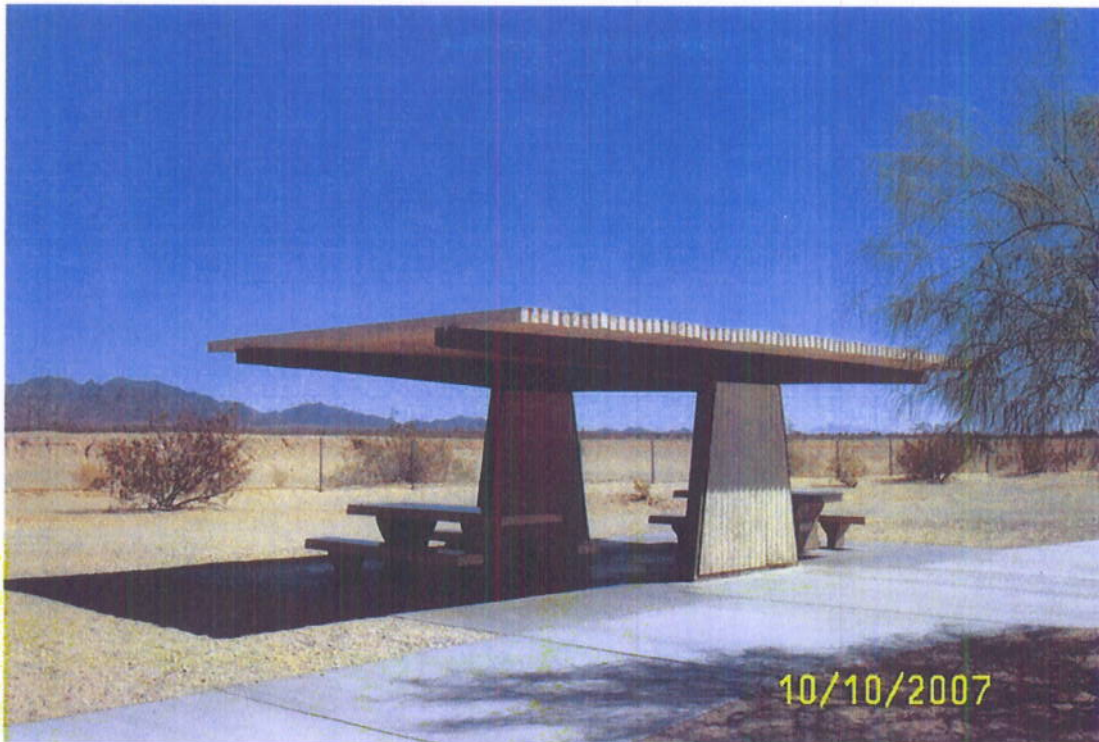
Photograph No. 3
View of Picnic Shelter Area #1.

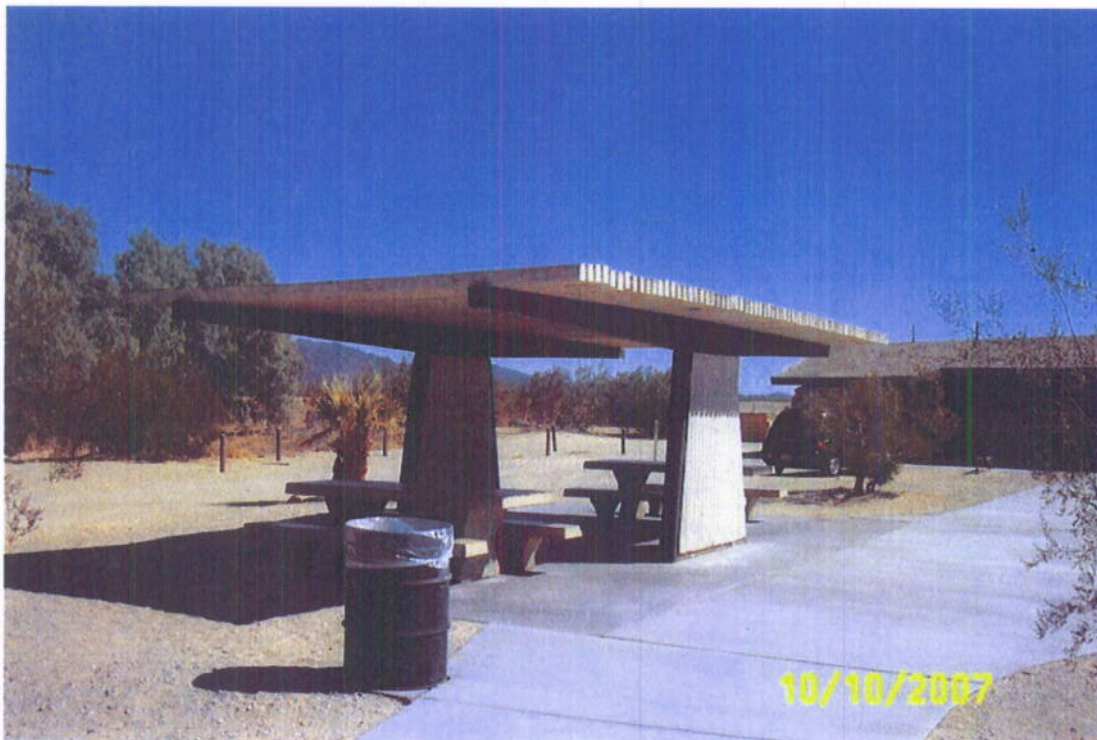
Photograph No. 4
View of Picnic Shelter Area #2.

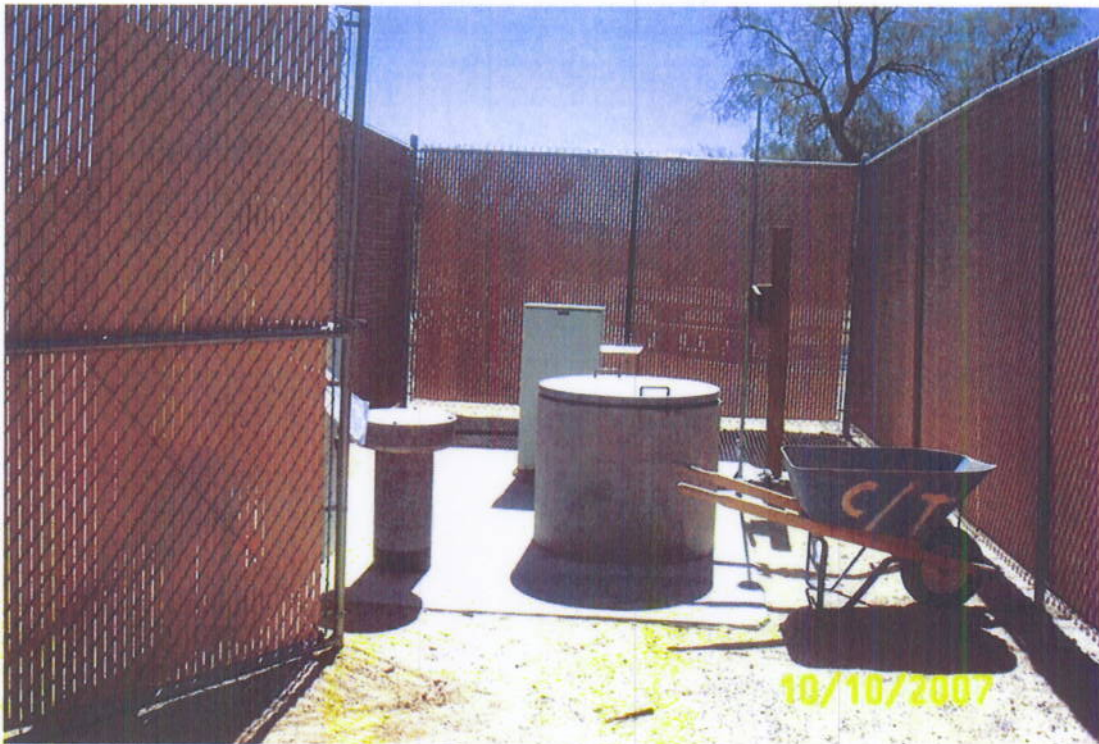
Photograph No. 5
View of Water Well Enclosure Area.

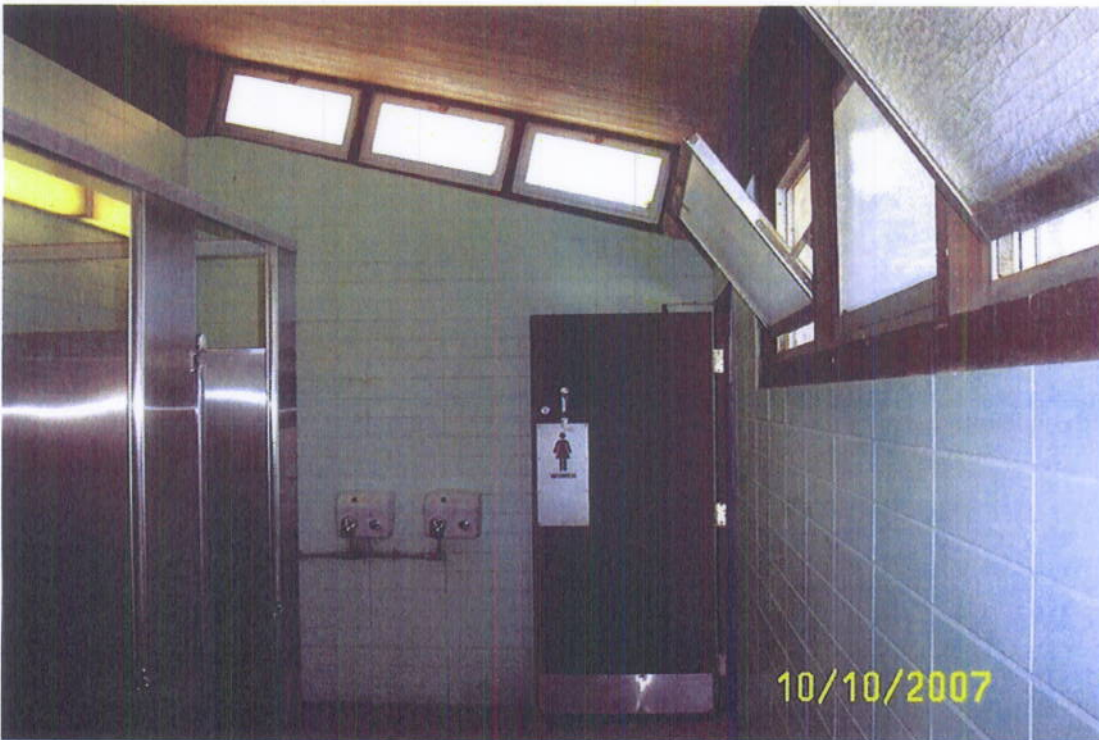
Photograph No. 6
Representative View of Restroom Interior.

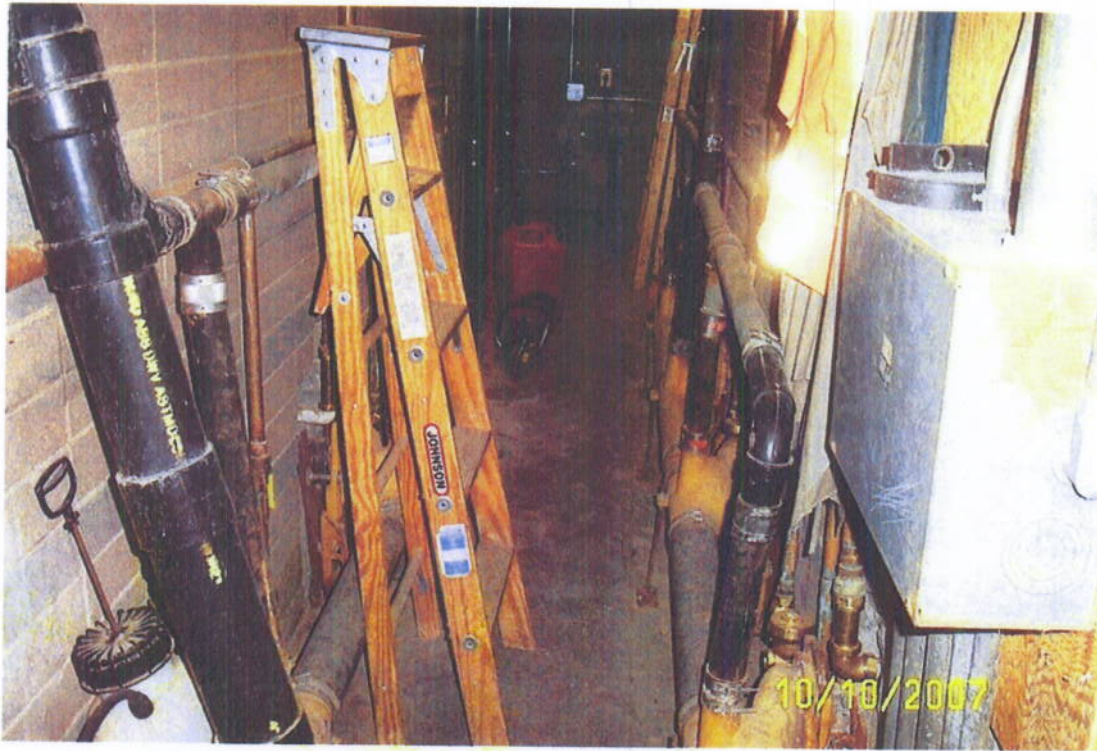
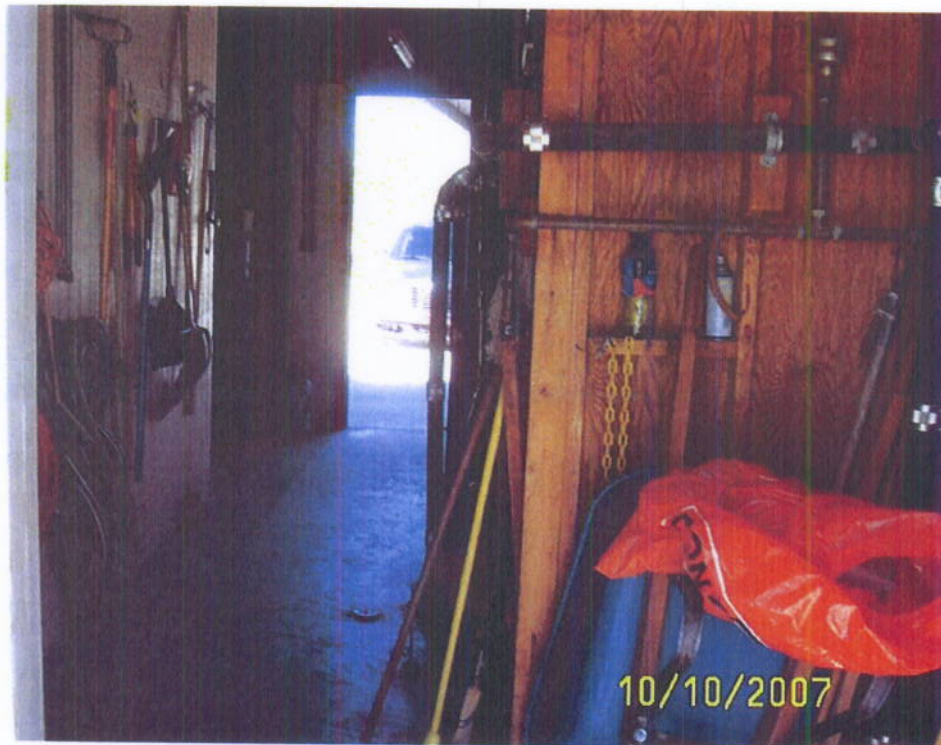
Photograph No. 7 & 8
View of Maintenance Room inside Restroom Building.
